Evaluative Testing of Sheep Ranching Sites 5LA2316, 5LA2366, and 5LA2359 on the Piñon Canyon Maneuver Site,
Las Animas County, Colorado

Fort Carson Cultural Resources Management Series Contribution Number 17
by
Minette Church and Kimberly Henderson

Department of Anthropology University of Colorado at Colorado Springs Colorado Springs, CO 80933

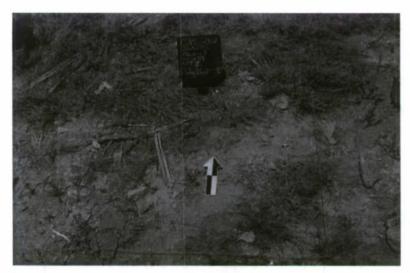
Figure 13: Unit 33 Lot 0 North Facing

EU 33 was located about 3 m southwest of the eastern rock wall alignment and in the "center" of Feature 3. No indications of additional features or floor were discovered. Several domestic artifacts were recovered underneath a rock cluster that was thought to be part of a wall. Artifacts included stoneware, several different fragments of glass, and a variety of nails and flat metal fragments. The majority of the artifacts came from the first 10 cm of excavation.

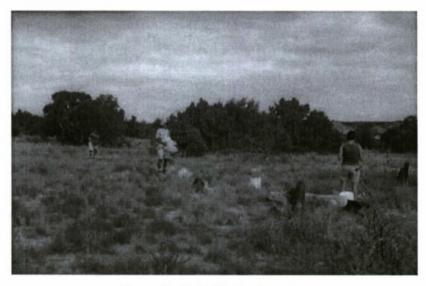
Figure 39: 5LA2359 Site Overview

Site 5LA2359 is a sheep camp, probably associated with 5LA2366 and sheep ranching activities of Vigil, S. T. Brown, and B. Gutierrez and Brown Sheep Camp (SW of here). Features include a shallow depression (Feature 2) with a surrounding, very light artifact scatter of domestic debris, including can, glass, spoon, and ceramic. About 10 m south of Feature 2 is a juniper with high grass where an animal was probably tethered. (It is the only juniper in area with such rich, tall grass beneath, in even circumference around it). There are two corrals made of piled juniper limbs, one north of Feature 2 and one in the south portion of the site, with no associated artifacts. Some metate fragments and light flake scatters located at the site had no observable association with historic scatters or features.

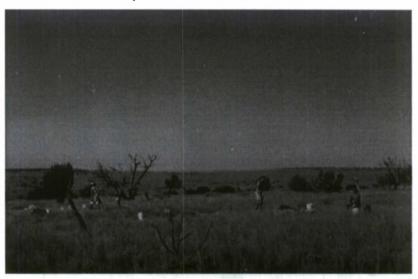
Figure 41: 5LA366 Site Overview

Site 5LA2366 is a relatively extensive sheep herder camp which seems to display two components and may have been used seasonally. The first occupation was homesteading and sheep ranching and dates from 1870 to 1890. The second occurred during the era of larger scale sheep herding and dates from 1910 to 1930. There are two definite and one possible dugout features. The first two have associated hearth and ash features and an artifact scatter (with earlier 1870-1890 materials). There is a cistern, a pile of posts (possible dugout roofing), and a corral complex with another associated concentration of materials dating between 1910 and 1930. Most materials were collected by original recorders in 1984. There is also a shallow linear swale on the southeast area of the site that may be an old road into the site.

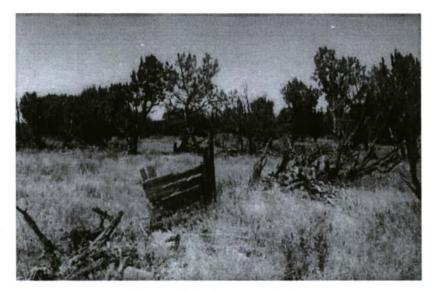
Figure 42: Feature 1 View West

Feature 1 is a post-and-wire corral with brush limb construction. Its dimensions are approximately 26 x 49 m.

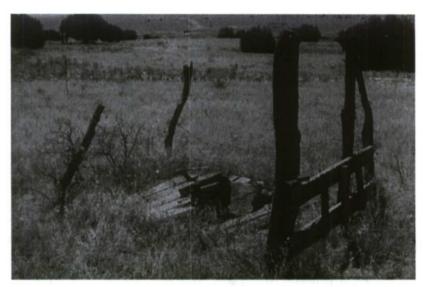
Figure 44: Feature 4

Feature 4 is a plaster-lined cistern with a superstructure of milled wood, wire and sheet metal. It is 1.6 m in diameter.

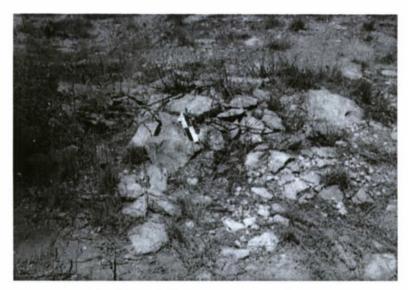
Figure 45: Feature 5 View North

Feature 5 is a shallow dugout dug into limestone with no superstructure visible. The dimensions are approximately 5 x 7 m.

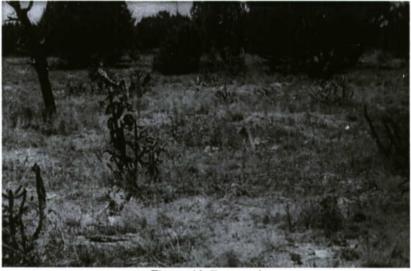
Figure 46: Feature 6

Feature 6 is a shallow dugout dug into limestone with no superstructure visible. The dimensions are approximately $5 \times 4 \text{ m}$.

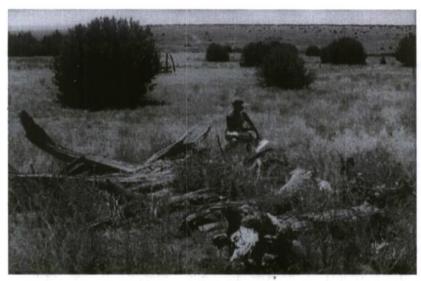
Figure 47: Feature 8

Feature 8 is a juniper post dugout with milled lumber construction. The dimensions are approximately $3 \times 4.5 \text{ m}$.
